TRANSIT PASSENGER FACILITIES DEVELOPMENT PLAN FOR LAKE COUNTY, CALIFORNIA

FINAL REPORT

Lake County/City Area Planning Council

LSC Transportation Consultants, Inc.
and Pat Piras Consulting

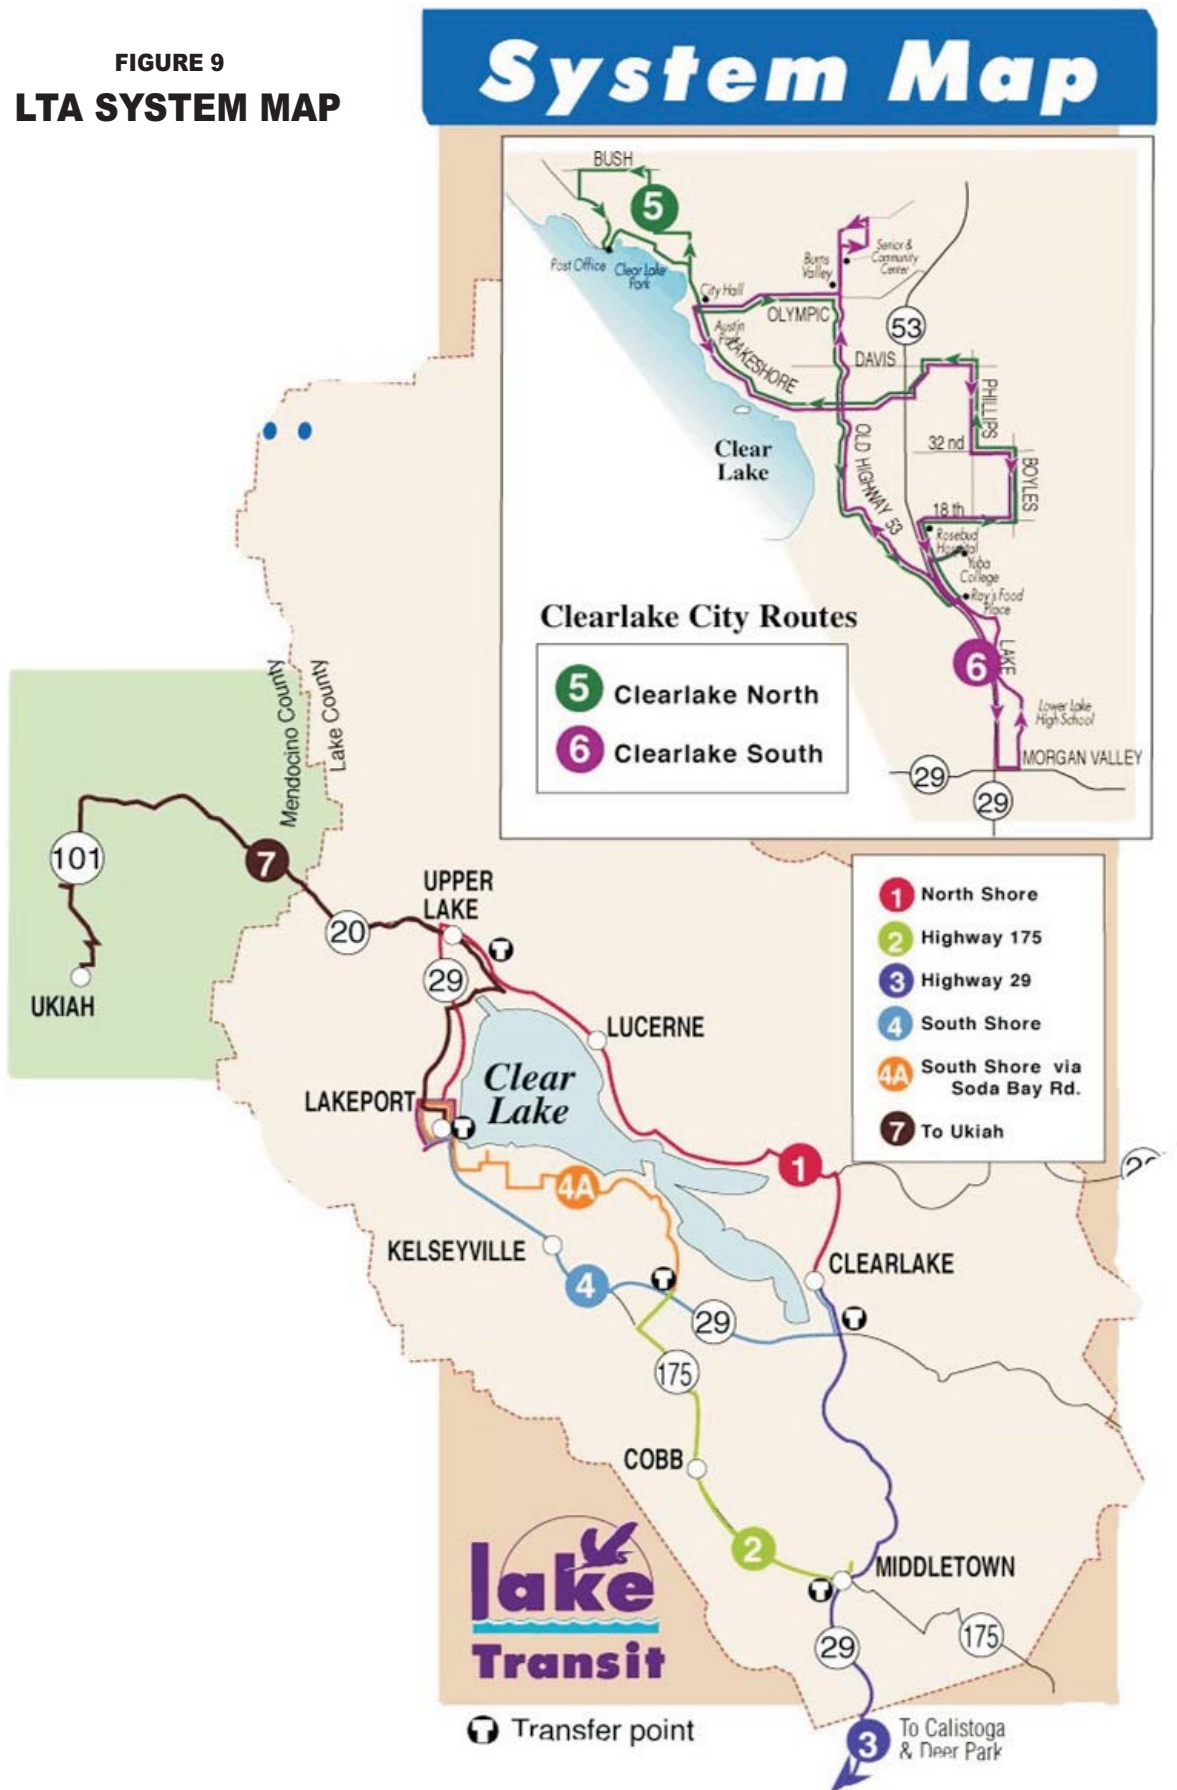
FIGURE 9
LTA SYSTEM MAP

The following transit passenger facility plan was categorized by community area for unincorporated Lake County and “municipality” for Clearlake and Lakeport. A priority implementation list for each specific area was determined based on various factors including the presence and condition of a bus stop sign, safety, traffic volumes on the adjacent roadway which determines the need for a safe bus pull-off area, and boarding and alighting counts at each stop. These factors were used to prioritize bus stop facility improvements. Figure 8 illustrates all of the existing LTA bus stop facilities in Lake County. Figure 9 illustrates the LTA System Map, which shows each route and the area served.

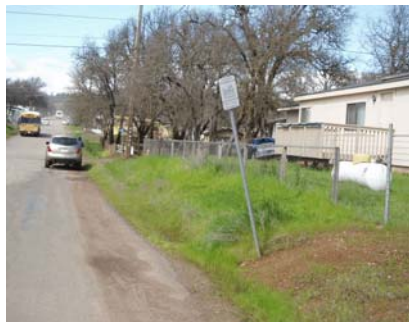
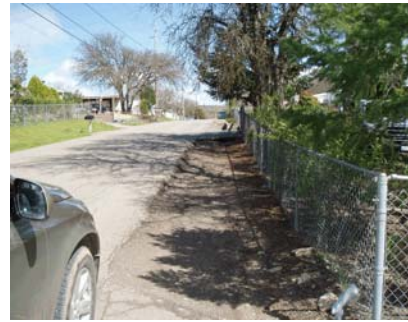
Typical residential streets in Clearlake.

The LTA transit system might utilize such "unimproved" stops in residential areas by installing bus stop pads in order to create an accessible bus stop. The challenges for installing improvements include the acquisition of right-of-way as well as private property.

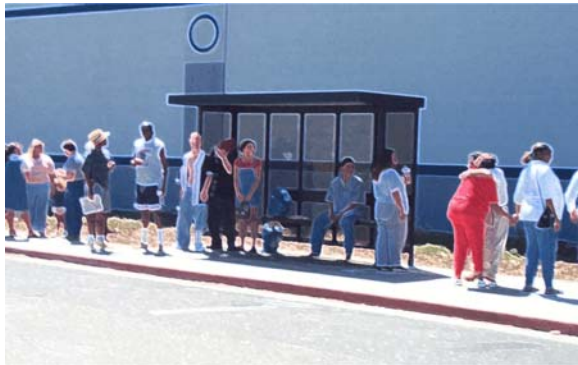
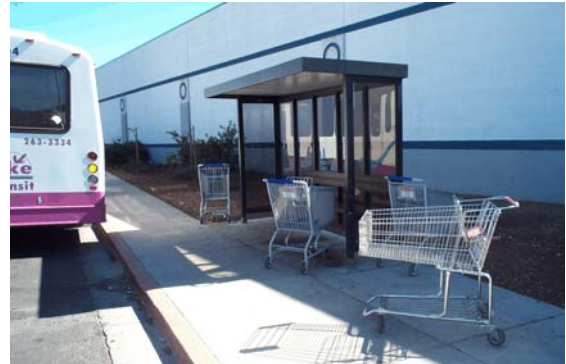
**Ray's Food Place, Clearlake
Routes 1, 3, 4, 5 & 6**

for landscape improvements to mitigate the damage that waiting passengers are doing to the area. This could include more paving, raised planter boxes, trees, shopping cart corral, etc. The project should be done cooperatively with Ray's. Since they are providing the space, LTA should provide improvement funding based on an agreement for continuing use as a bus stop.

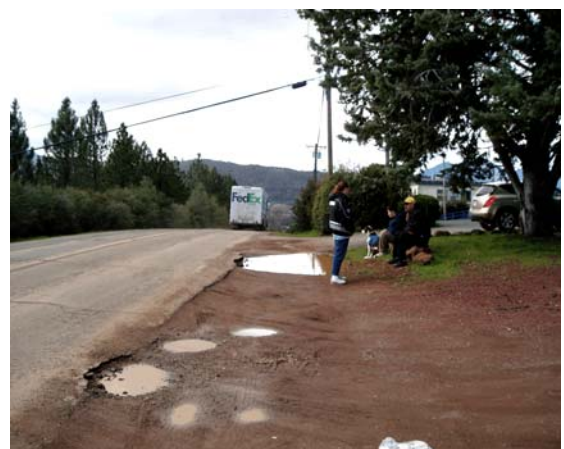
**Highlands Medical Center
Route 6 Westbound**

The bus stop at the crest of 18th Street in Clearlake currently serves the Highlands Medical Center offices. Due to the location, both the transit vehicle driver and oncoming drivers have poor sight distance. It is recommended that the stop be relocated to the parking lot area adjacent to the medical office to ensure a safe boarding and alighting zone.

Additionally, Route 6 westbound does not serve the Redbud Hospital due to grade, curve, and congestion in the parking lot. It is recommended that LTA provide a note in the schedule indicating that convenient service to the hospital is only provided by Route 5, not Route 6. This is due to the fact that some passengers currently use this stop to access the Redbud Hospital, which is not recommended.

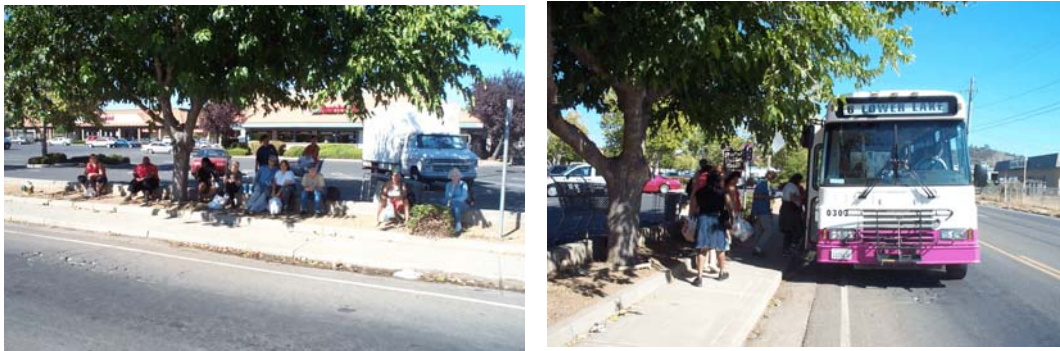
**Burns Valley Mall
Route 6 Westbound**

As mentioned, a key issue in Lake County is that many existing retail, commercial, and office facilities have not allocated space for bus stops. A critical existing concern at this time is the lack of pullout space for "designated" stop ID# 60.18, which is located on Olympic Drive and serves Burns Valley Mall in the westbound direction. While there is no pullout space due to limited public right-of-way, it would be necessary to work with the property manager at Burns Valley Mall in order to ensure adequate space for the installation of a pullout as well as a bus stop landing pad and shelter. Fortunately, at this time, vehicles have the ability to avoid the bus by using the center turning lane on Olympic Drive.

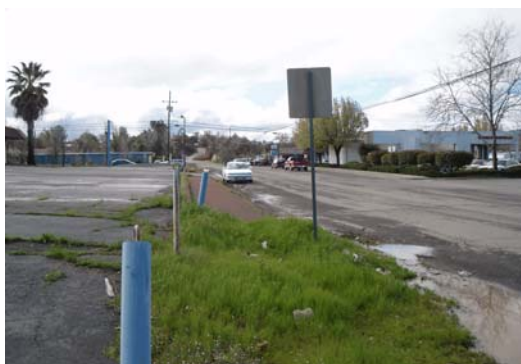
**Safeway/Burns Valley Mall
Route 6 Northbound**

There is also a lack of "designated" stops in close proximity to Safeway on Burns Valley Road, adjacent to the Burns Valley Mall. As a result, it is recommended that bus stop ID#'s 60.14 and 60.17, which have been ad hoc stops up to this point serving the Safeway in both the north and southbound directions, become officially designated bus stops. At this time, passengers waiting for the bus on either side of Burns Valley Road do not have a designated waiting area, nor is there an existing sign to indicate an LTA bus stop location. It is also not possible to load a wheelchair on the west side, and it is difficult for the bus to pull completely out of the lane of travel.

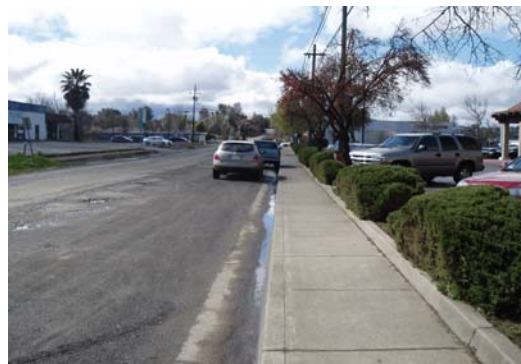
**Safeway/Burns Valley Mall
Route 6 Southbound**

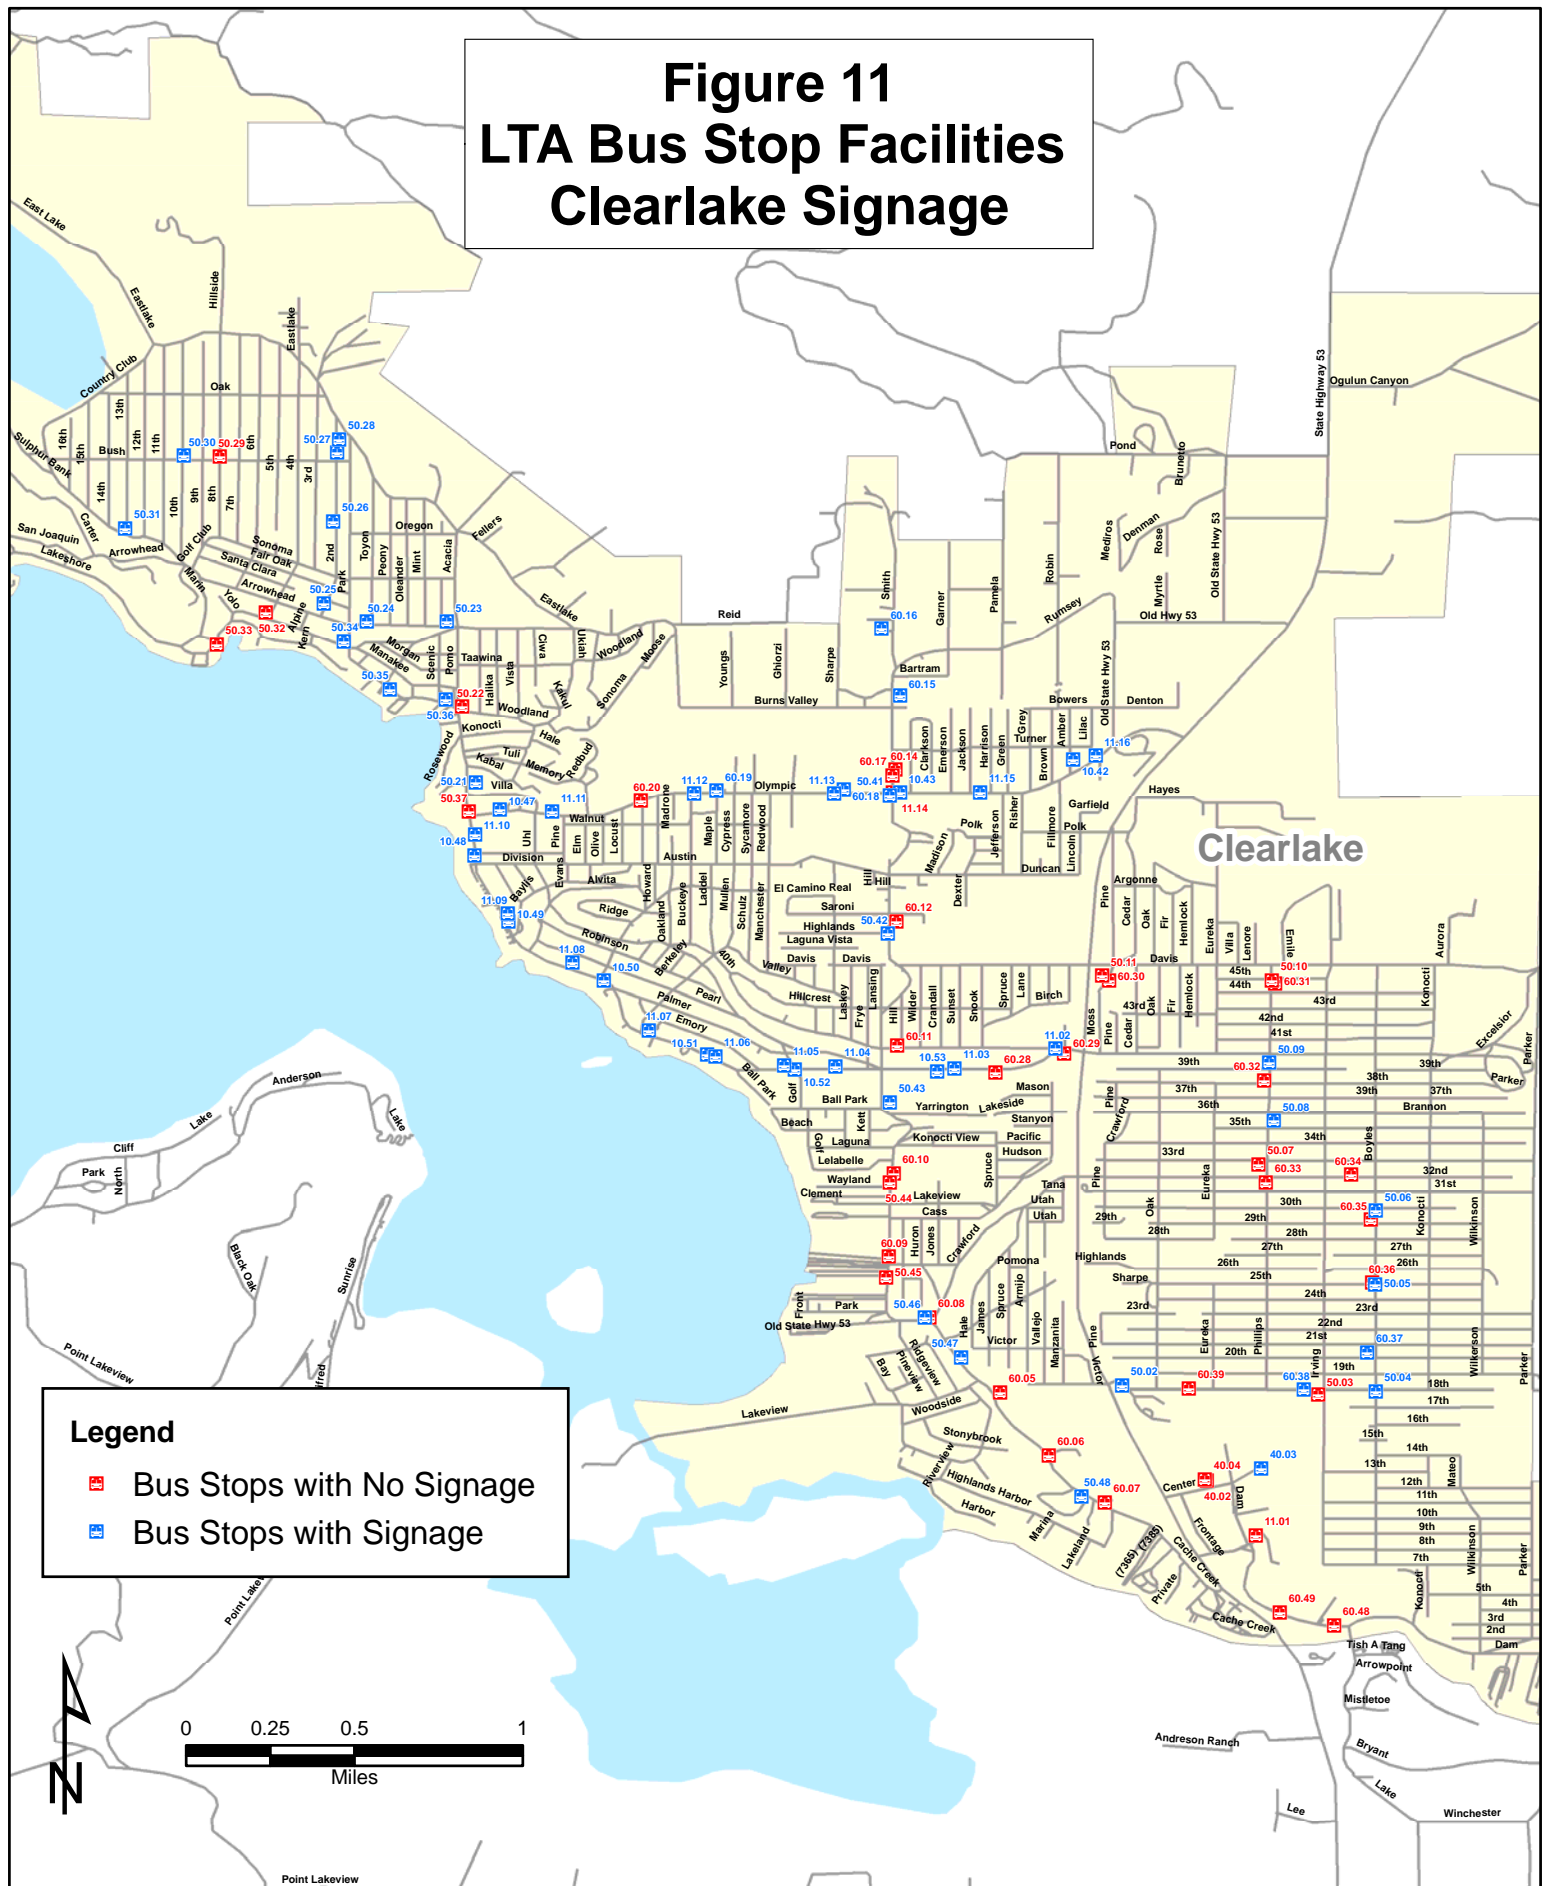
Figure 11 LTA Bus Stop Facilities Clearlake Signage

As described in Tables 3 and 4, 38 LTA bus stop facilities in the city of Clearlake require signage (approximately 47 percent of the system total). In a few instances the sign or pole may need to be repaired. Figure 11 illustrates bus stop facilities in Clearlake with and without existing signage.

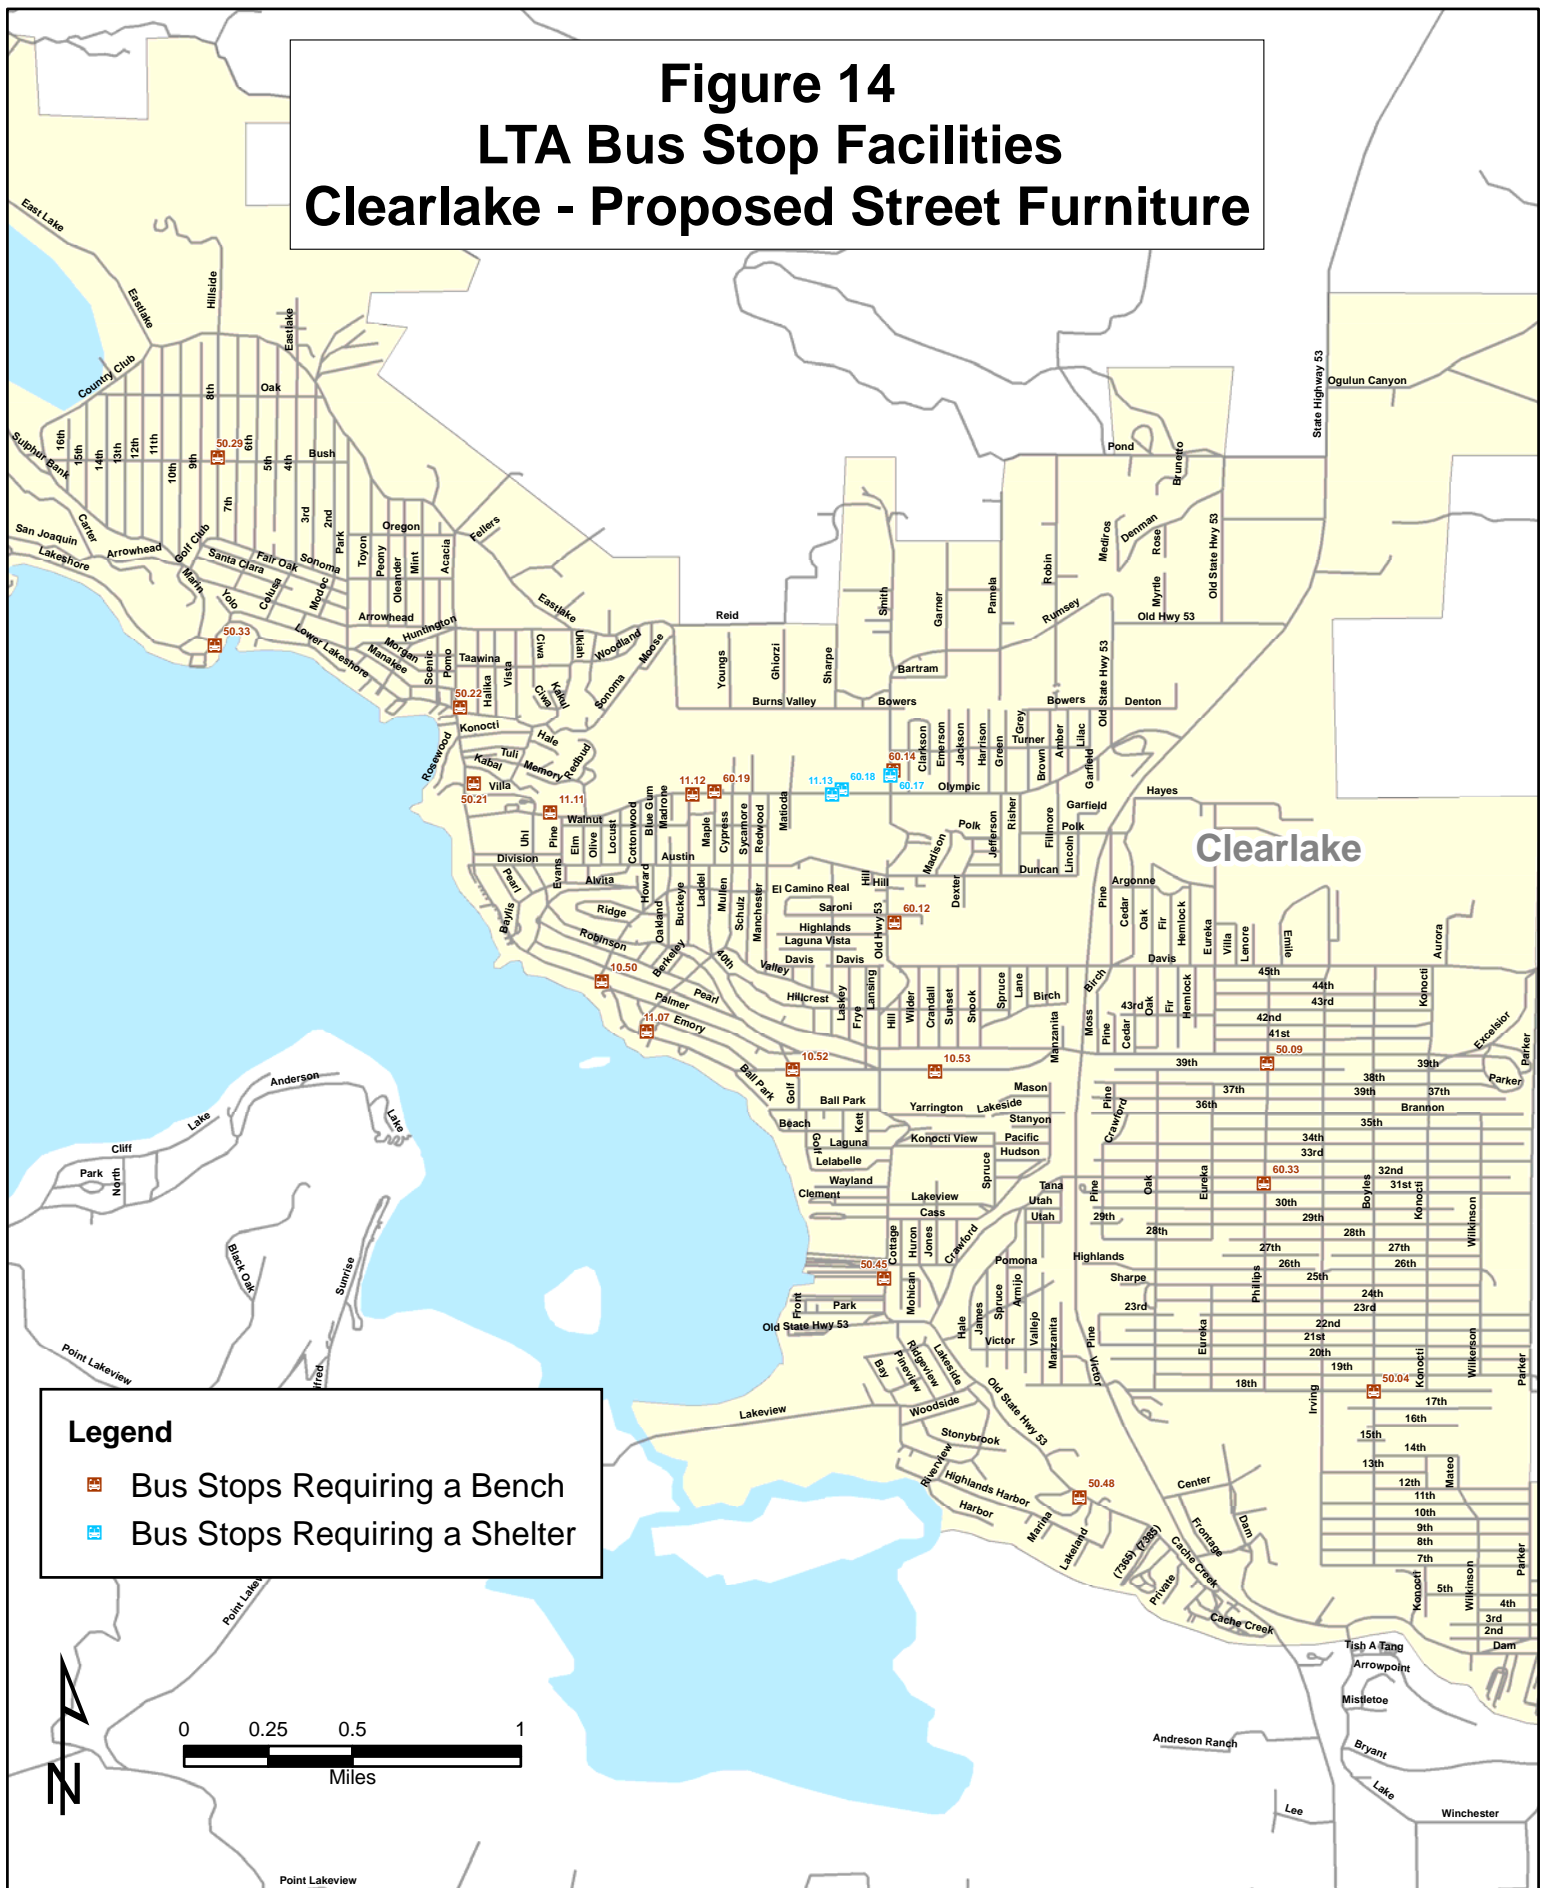
Clearlake - Proposed Street Furniture

LTA Bus Stop Facilities

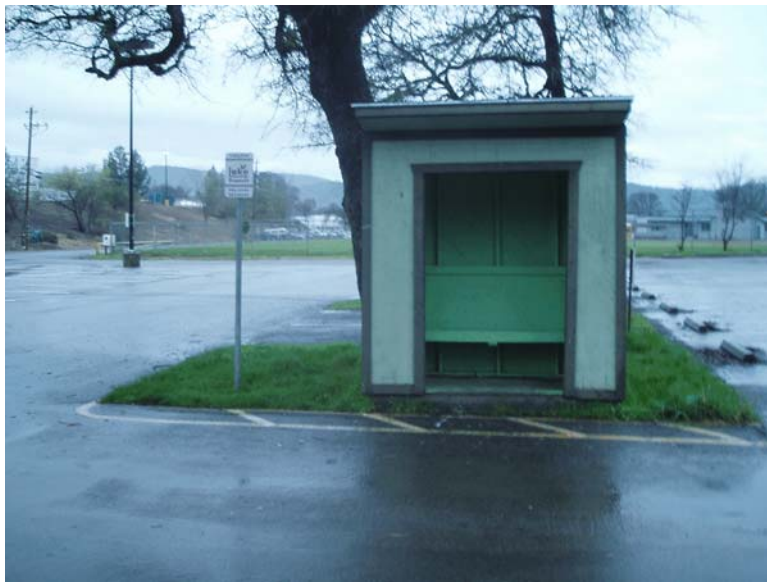
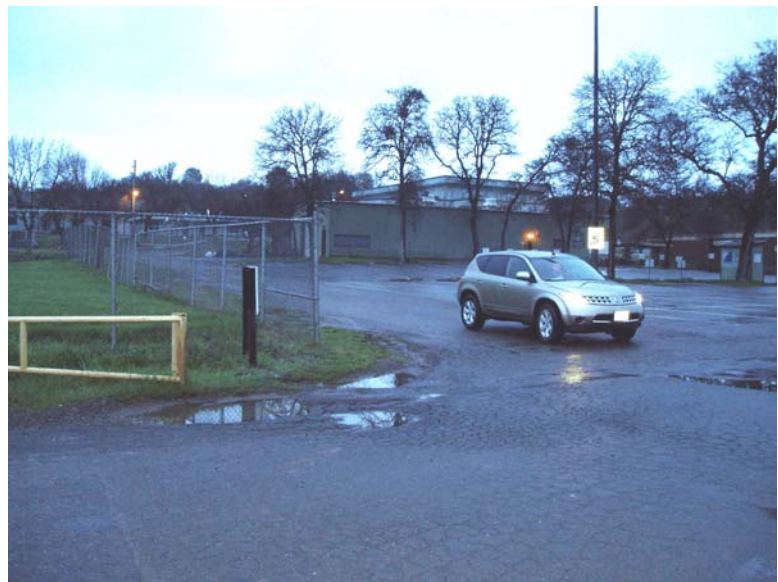
**Yuba College Parking Lot and Existing Shelter
Routes 4, 5, and 6**

The current location of the bus stop facility at Yuba College, which serves the college and the neighboring middle school, is not at an optimal location in terms of passenger boarding and alighting. Specifically, the bus blocks a travel lane, blocks several parking spaces, and drops passengers in the middle of a parking aisle. It is proposed that the shelter be relocated to the west of its present location to the northwest corner of the lot, adjacent to the maintenance garage facility. It is also recommended that an accessible path from the new shelter location to the various administrative and classroom buildings should be constructed. This new location is more appropriate for the loading and unloading of passengers because, unlike the present location, it will allow the transit vehicle to board and alight passengers on the correct side of the vehicle. The new site would also be located in a safer location on the side of the parking lot rather than in the center where there is more traffic congestion. Figure 15 illustrates this improvement at Yuba College.

**Yuba College Parking Lot
Routes 4, 5, and 6**

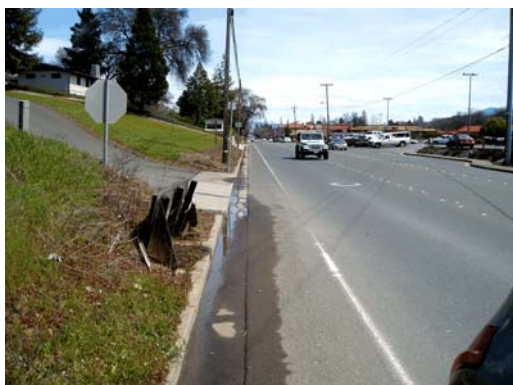
**Willow Tree Plaza/Safeway
Route 1 Westbound**

Both bus stops adjacent to the Willow Tree Plaza and the Safeway market on 11th Street in Lakeport create a potential traffic safety hazard. Stop 11.60 serves the shopping center in the westbound direction and 41.24 serves the area in the eastbound direction. There is no safe pull-out location in the westbound lane along 11th Street. The eastbound bus currently stops in the turn lane at the entrance of the Safeway, where it blocks or conflicts with turning movements. In order to resolve this safety issue, it is recommended that a new on-site stop should be constructed to serve buses traveling in both directions.

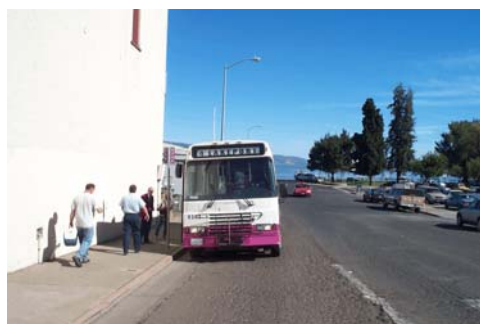
Third and Main, Lakeport

The existing bus stop location at Third Street and Main Street in Lakeport currently unloads passengers on a steep grade. As a result, passengers using a wheelchair do not have access to a flat and stable surface when boarding and alighting at this location. It is recommended that the stop location should be relocated to the facility that exists in front of the courthouse on the corner of Main Street and Third Street.

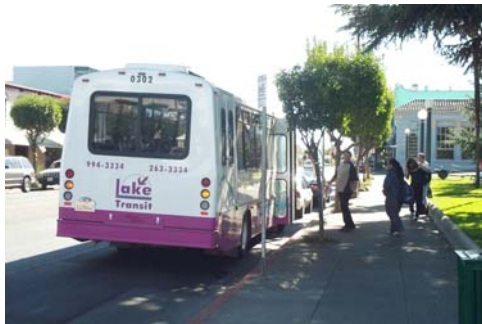
Main and Third, Lakeport

It is recommended that the existing bus stop location at Third and Main Street should be relocated to the facility that exists in front of the Court House on the corner of Main Street and Third Street. As a result, the existing bus stop facility in front of the Courthouse will need to accommodate more demand. It is recommended that a larger designated passenger waiting area is implemented. It is also recommended that the red curb zone is extended to the south by a approximately 100 feet in order to allow the bus to safely merge into traffic.

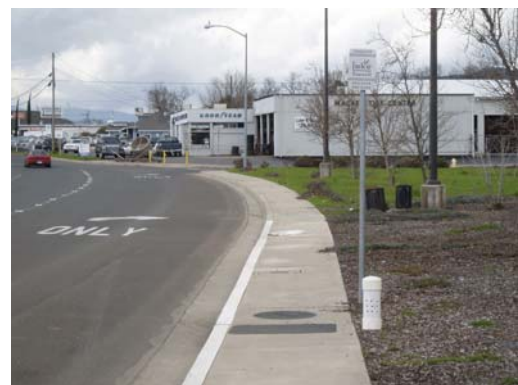
**Kmart, South Main Street
Lakeport Routes 4/4a**

The existing bus stop location for the Kmart on South Main Street in Lakeport requires the bus to pull out in the taper for a right-turn lane. The property includes Kmart, Social Security, and Kragen Auto. A major issue is the lack of adequate northbound bus stops to access this site. There is no right-of-way, it is a busy street, and there are no controlled crossings.

An on-site bus stop facility has been requested by Social Security, and a likely location is the sidewalk in front of Kragen Auto. It is recommended that a pullout be constructed and a bench be installed at this stop location. In recent years, coordination with this property has not been successful. Further effort between property management and LTA staff is recommended to secure the space necessary for a proper transit facility. This effort could be facilitated by the implementation of the proposed land use policy described earlier in this report.

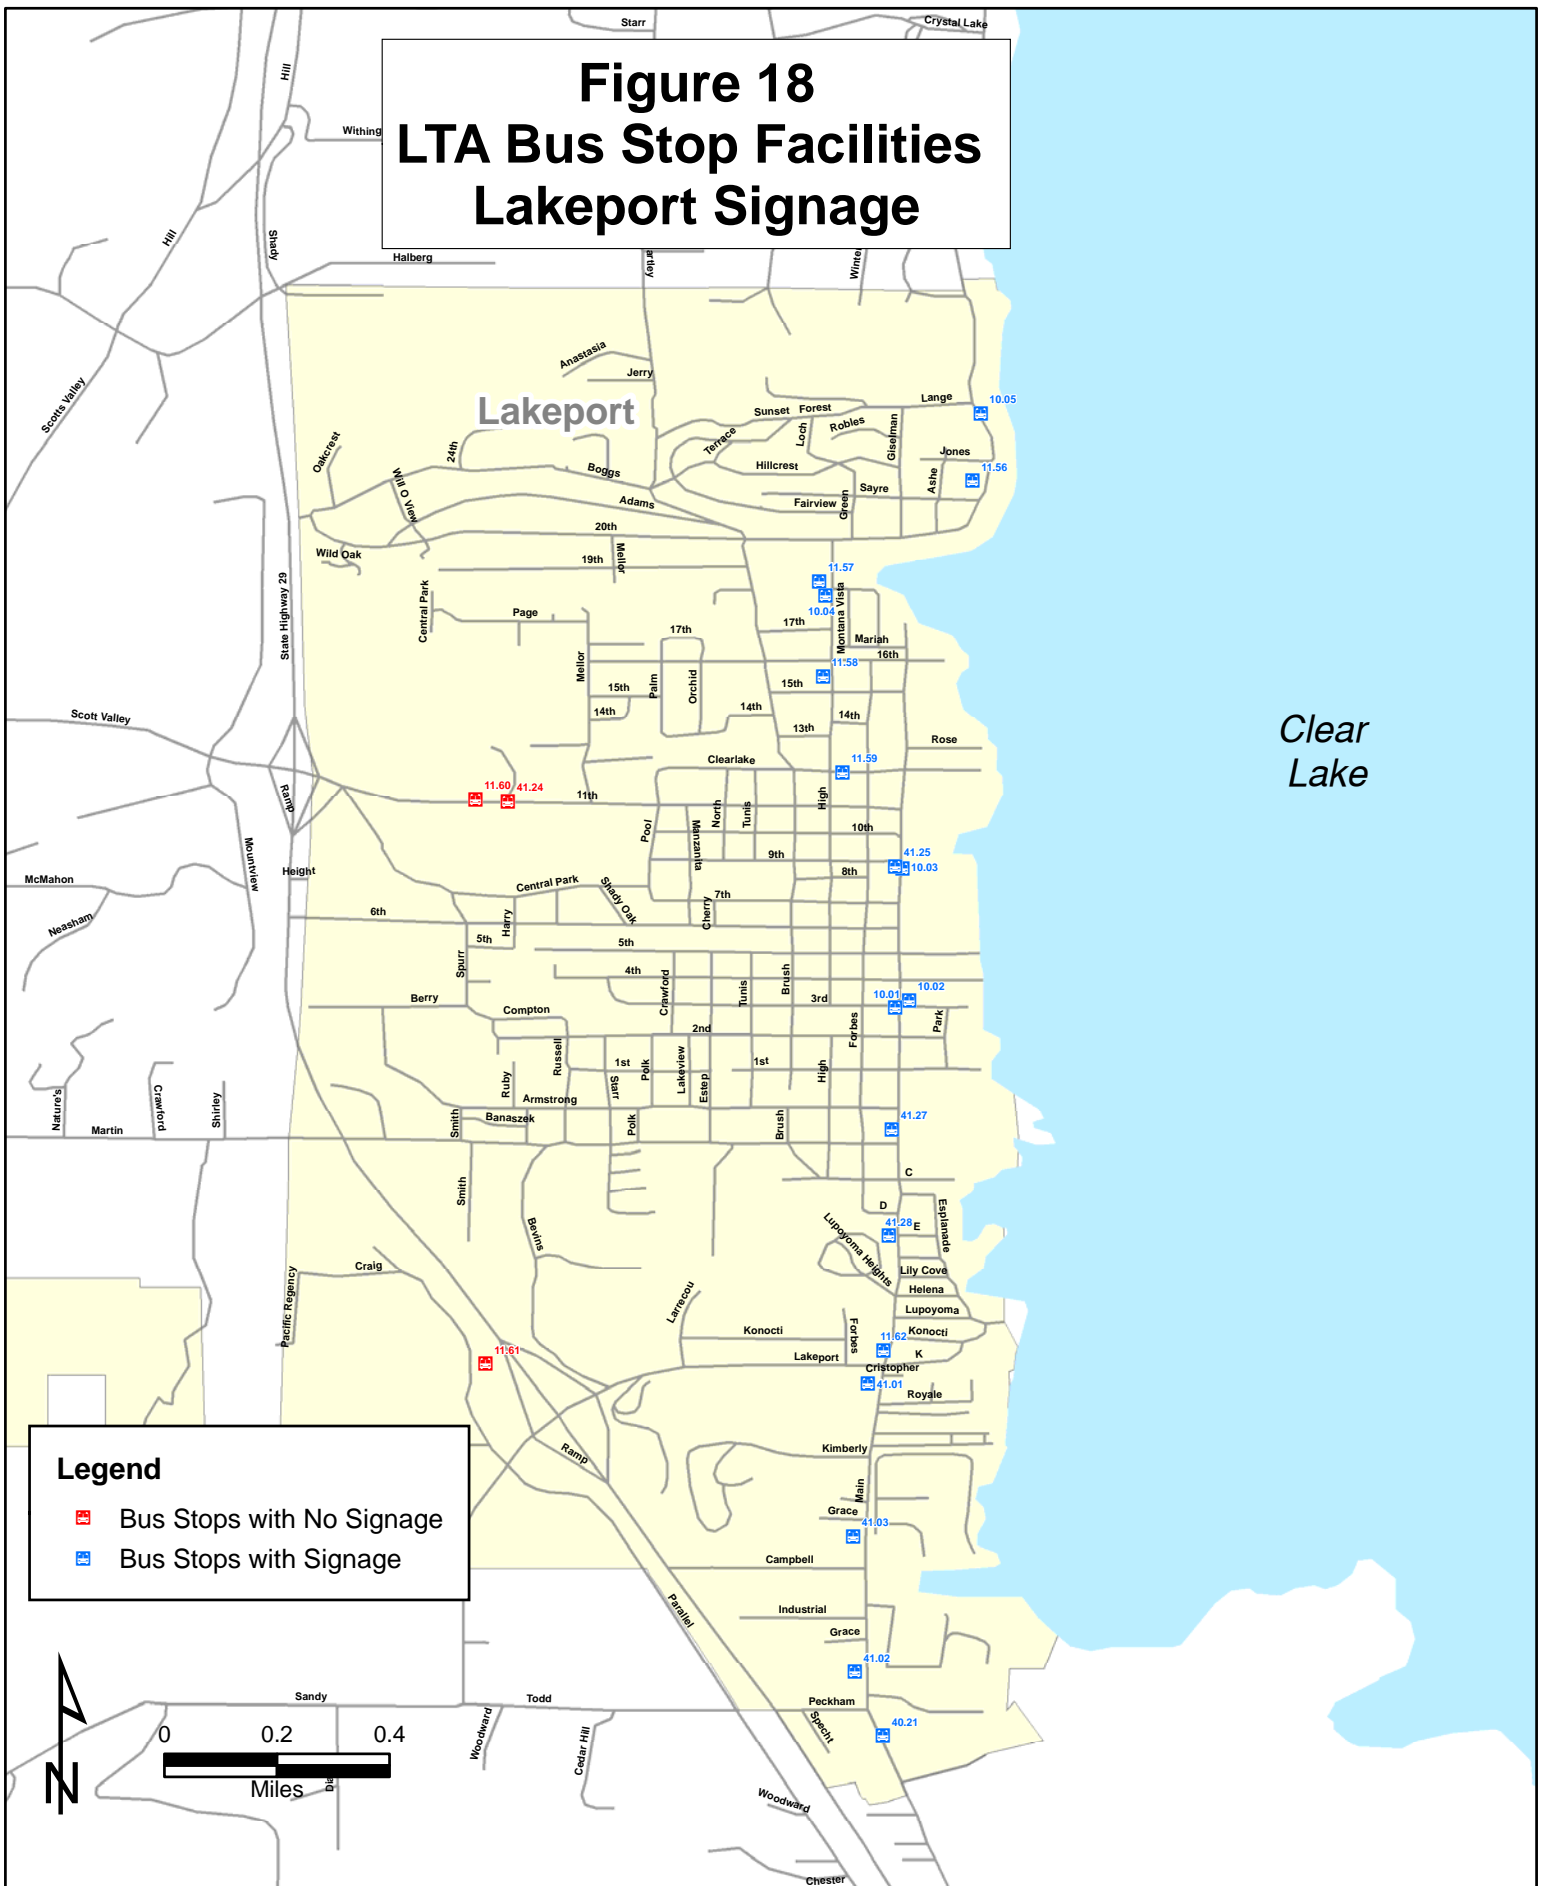
Figure 18 LTA Bus Stop Facilities Lakeport Signage

As shown in Tables 9 and 10, only 3 LTA bus stop facilities in the City of Lakeport require signage. Figure 18 illustrates bus stop facilities in Lakeport with and without existing signage.

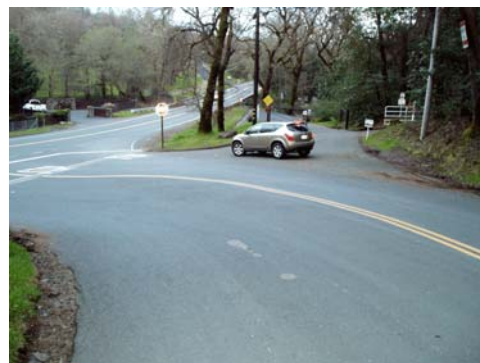
**Anderson Springs Road
Route 2 Southbound**

According to LTA staff, in order to serve passengers traveling southbound on Route 2, the transit vehicle currently makes a right-hand turn onto Anderson Springs Road followed by an immediate U-turn before parking on the opposite side of the road. Sight distance is poor for both the driver of the transit vehicle and oncoming traffic due to a hill. In order to reduce the potential for accidents, it is recommended that the stop is permanently relocated roughly 100 feet to the south of the Anderson Springs Road turnoff to an existing large gravel pullout area along SR 175. The location change will require patrons to walk a short distance in order to board and alight the vehicle. It is also recommended that a sign should be installed at the new location.

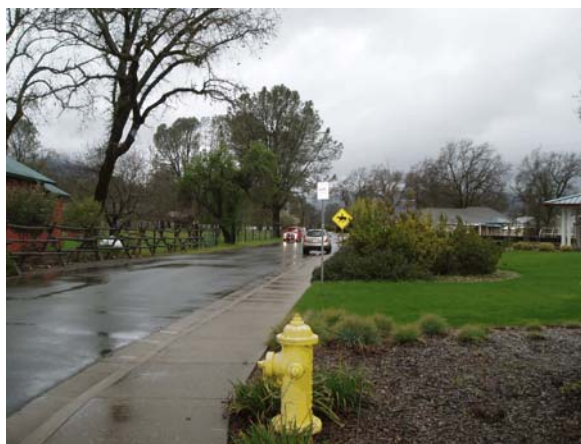
**Middletown Senior Center
Route 3 Southbound**

While the Middletown Senior Center currently has a signed bus stop on Route 3, it lacks an accessible path and bus stop pad that meet ADA requirements. It is recommended that a bench should be installed and an accessible path from the entrance of the senior center to the stop should be constructed, along with an ADA compliant bus stop pad.

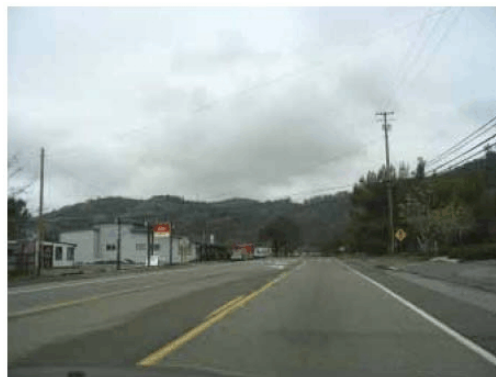
**Post Office Looking West -
Clearlake Oaks**

- Implement 1 new bus shelter and bus landing pad on the north side of Highway 20 at Keys Boulevard west of the shopping center driveway.

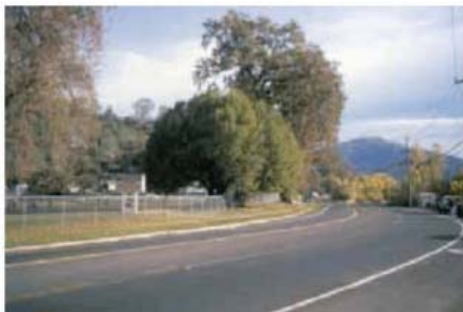
**At Lucerne Elementary
Looking East**

Currently, Route 1 follows Country Club Road eastbound through Lucerne. In order to be in conjunction with the improved streetscape elements presented in the *Calming Plan*, it is recommended that Route 1 eastbound is relocated to Highway 20. As the elements of the *Calming Plan* may not be fully implemented for a few years, the relocation of Route 1 should not occur until the alternatives are finalized and the improvements are constructed. The precise location of each bus stop will thereby be determined upon completion of the *Calming Plan* elements and will correlate with both the crosswalk locations as well as the bus stops located on the north side of Highway 20, which serve Route 1 in the westbound direction. Table 13 reflects the additional stops recommended along Highway 20 in the eastbound direction. For the purpose of calculating improvement costs, it has been estimated that an additional 6 to 8 bus stop locations will require the installation of a bus shelter, a bus pad, and a bus stop sign in adherence with the ADA guidelines. It is important to account for the fact that the *Calming Plan* was completed prior to this analysis and is still at the conceptual stage.

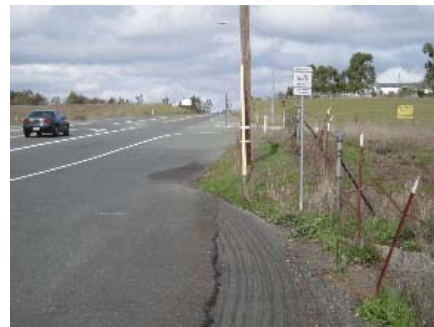
**Sentry Market Bus Stop
Route 1 Westbound**

The current bus stop location is on the north (far) side of the Sentry Market and serves westbound passengers. This requires passengers to cross SR 20 at a relatively high-traffic location, without a signal or other crossing protection. Recent, long-term counts of passenger activity at this stop were not available for this study. It is important to note that this stop is not unsafe in terms of accident history. The proposed improvement would enhance the viability of the stop by allowing passengers to feel more secure at an alternative stop location.

One option would be to route the westbound bus onto the south side of SR 20, such as through the Sentry parking lot. This has the disadvantages, however, of adding to the travel time of the route (particularly regarding making the left-turn movement back onto SR 20, as well as the safety issues associated with bus movements in the parking lot), and would not be warranted if ridership at this stop is low. LSC recommends that LTA staff collect passenger activity data at this stop.
